TECH TIP

VICON TECHNICAL SERVICES GROUP

Subject: RAID/KOL Troubleshooting - Tips
Product: RAID products
Number: 1400-0001-46-00
Date: 2/3/03

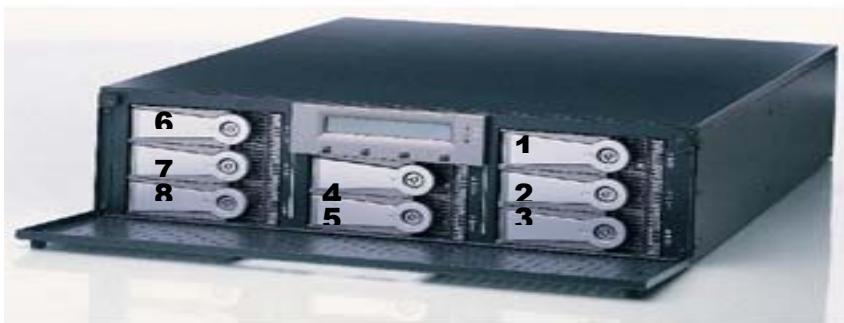
1. The original physical order of drives is critical and any moving of drives either in the same box or between boxes will cause critical failures.
