V80x, V81x, V93x and V95xx Series Camera Firmware

General Description

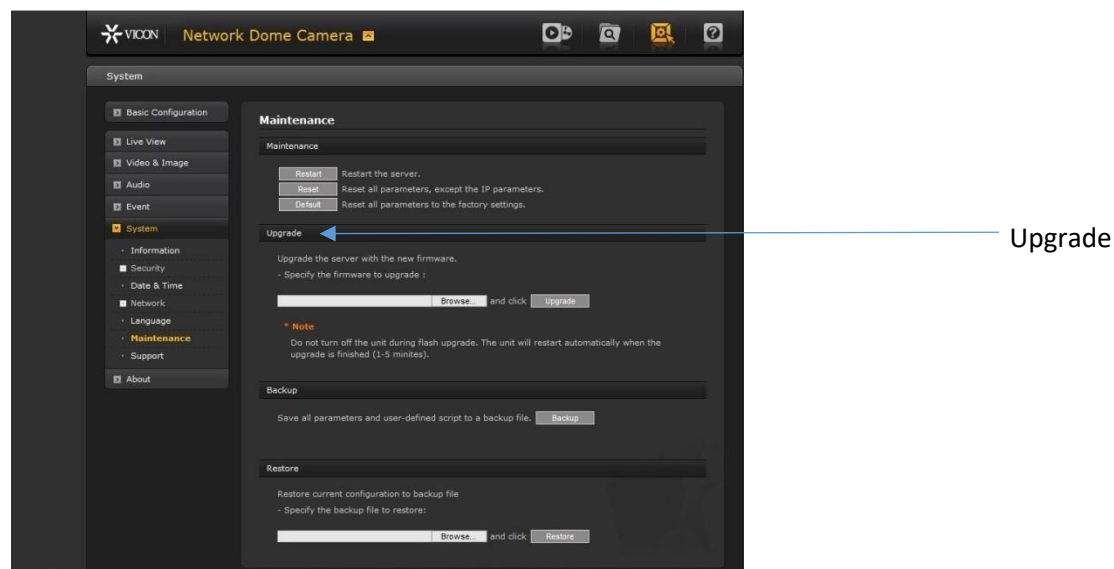
firmware to your PC. Go to the camera's Maintenance screen.

Open the Upgrade section and use the Browse button to locate the firmware on your PC. Press the upgrade button. During the upgrade process, do not turn off power to the camera. Wait at least 5 minutes and access the camera again. The intermediate firmware should be installed. Repeat this procedure for the final firmware version.

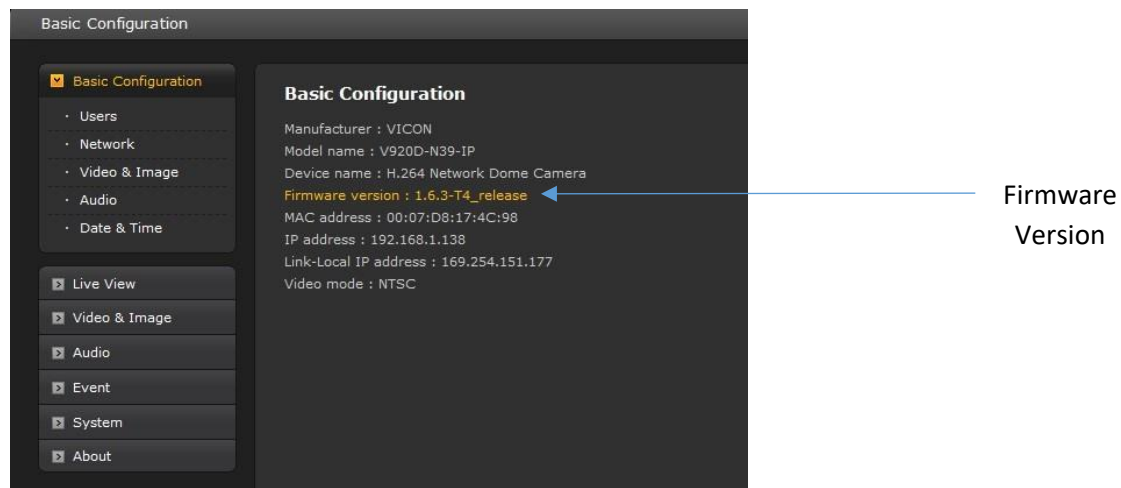
Once complete, the firmware version can be checked from the Basic Configuration screen.
