## X4 Firmware for Cameras: V-CELL-HD-B, V933EZ-312MIR, V923B-W39MIR-A, V923D-W39MIR-A, V932D-IR, V972D-N312IR and VLR-ENC-1

### General Description

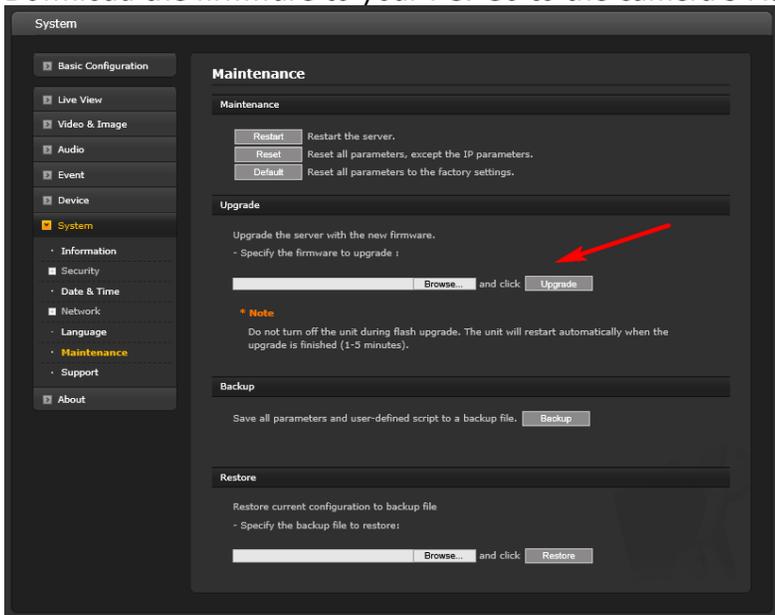
Download the firmware to your PC. Go to the camera's Maintenance screen:

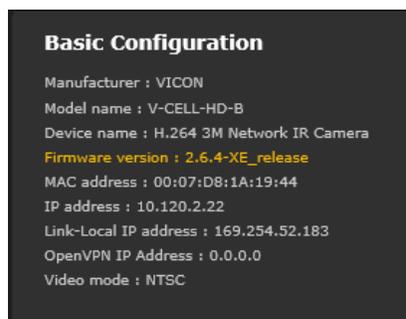
Open the Upgrade section and use the Browse button to locate the firmware on your PC. Press the upgrade button. During the upgrade process, do not turn off power to the camera. Wait at least 5 minutes and access the camera again. Once complete, the firmware version can be checked from the Basic Configuration screen.
