Initial Firmware for SN688D PTZ Dome Camera

General Description

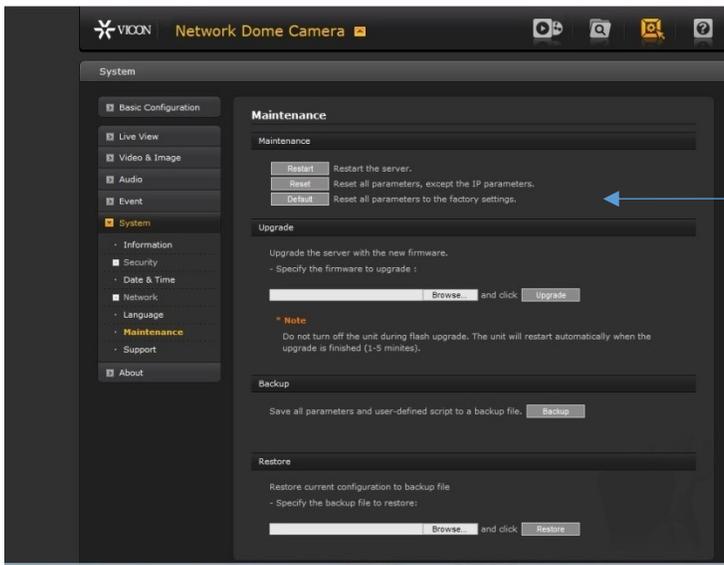
Update firmware

Download the firmware to your PC. Go to the camera's Maintenance screen:

Open the Upgrade section and use the Browse button to locate the firmware on your PC. Press the upgrade button. During the upgrade process, do not turn off power to the camera. Wait at least 5 minutes and access the camera again.

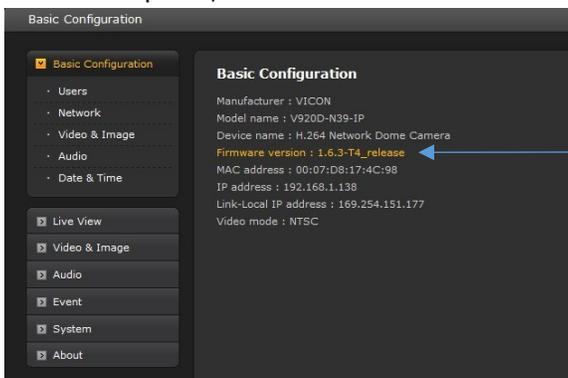
Updated firmware

Once complete, the firmware version can be checked from the Basic Configuration screen.
