Updated Firmware for V1000 Series Multi-Sensor Cameras

General Description

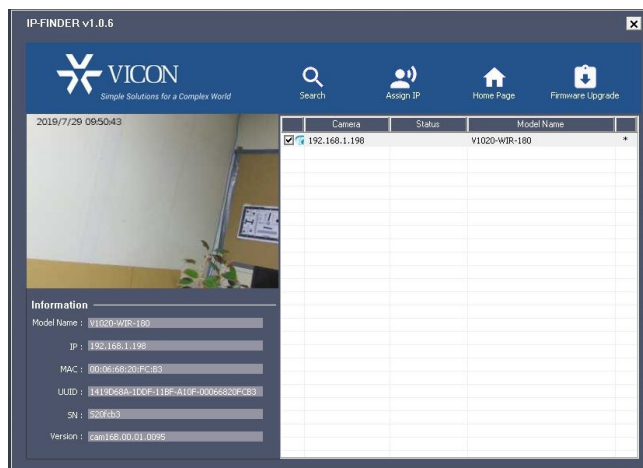
Alternatively, the Vicon IP Finder utility allows updating multiple cameras at the same time:
