## Updated Firmware (H-6314\_PTZ) for SN683D-WIR Camera

### General Description

Vicon has released firmware for production for the camera listed below. The accompanying SmartManager discovery tool has not been updated for this release. It is still at version v2.3.3.15.

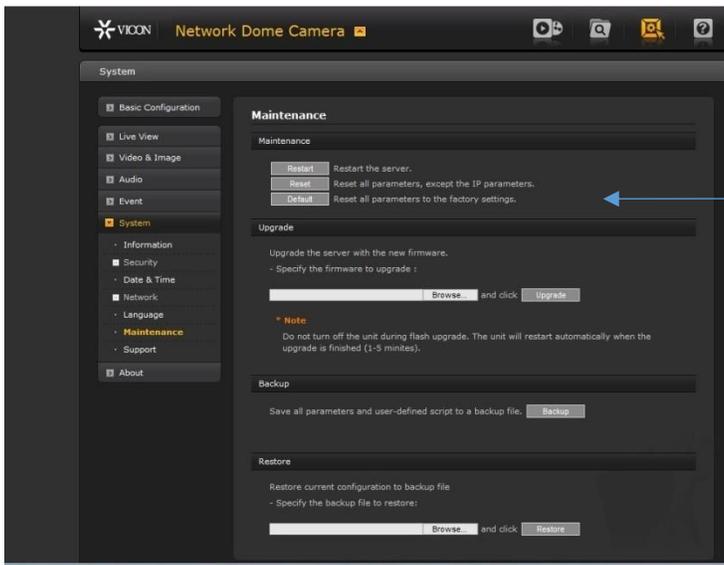
Update firmware

Download the firmware to your PC. Go to the camera's Maintenance screen:

Open the Upgrade section and use the Browse button to locate the firmware on your PC. Press the upgrade button. During the upgrade process, do not turn off power to the camera. Wait at least 5 minutes and access the camera again.

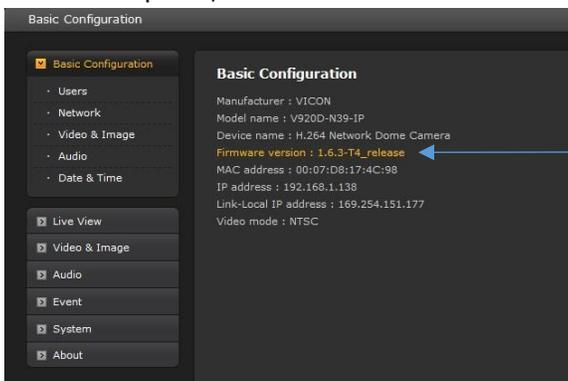
Updated firmware

Once complete, the firmware version can be checked from the Basic Configuration screen.
