Updated Firmware (H_2411) for: V812B-IR, V814B-IR, V812B-312MIR, V814B-312MIR, V932D-IR-1, V934D-IR, V9520D-312MIR, V9540D-312MIR, V9521D-312MIR, V9541D-312MIR Cameras

General Description

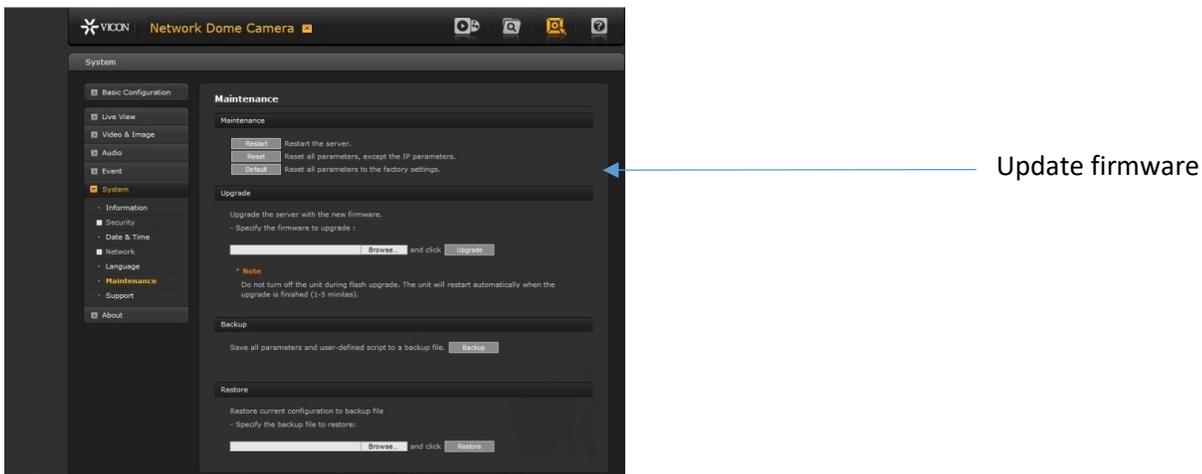
Download the firmware to your PC. Go to the camera's Maintenance screen:

Open the Upgrade section and use the Browse button to locate the firmware on your PC. Press the upgrade button. During the upgrade process, do not turn off power to the camera. Wait at least 5 minutes and access the camera again.

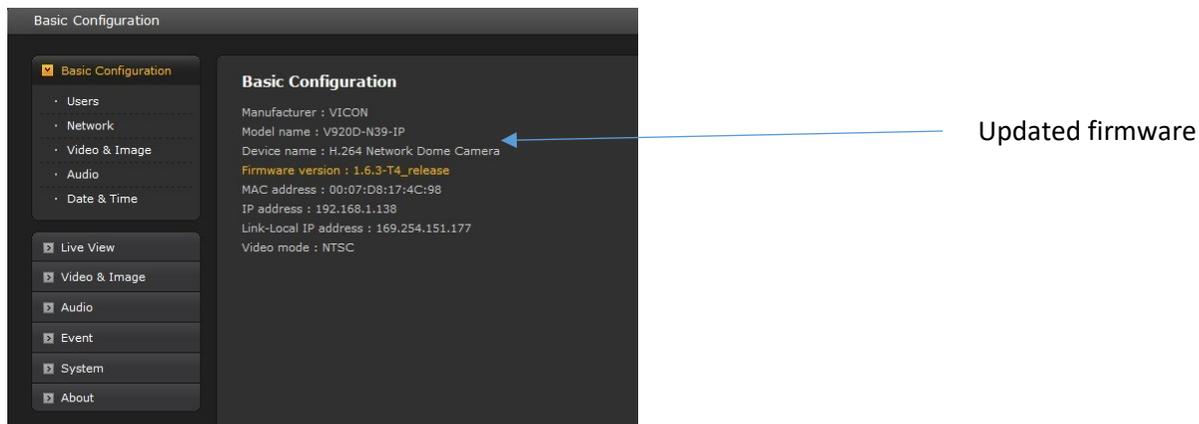
Once complete, the firmware version can be checked from the Basic Configuration screen.
