## X4 Firmware for Cameras: V-CELL-HD-B, V933EZ-312MIR, V923B-W39MIR-A, V923D-W39MIR-A, V932D-IR, V972D-N312IR and VLR-ENC-1

### General Description

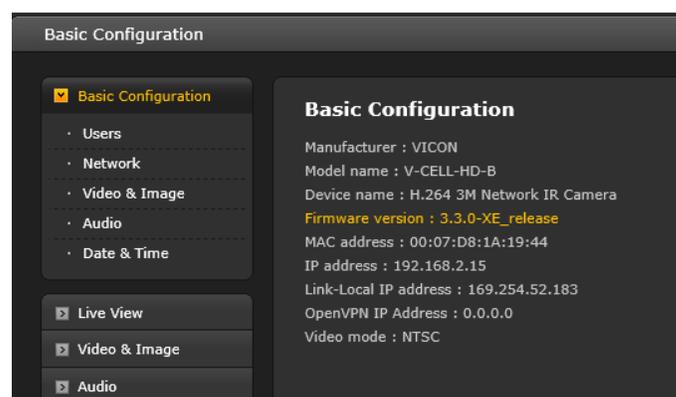
Once complete, the firmware version can be checked from the Basic Configuration screen:
