# Release Notes

June 2020

## Updated Firmware (H\_7817\_PTZ) for SN688D-WIR Cameras

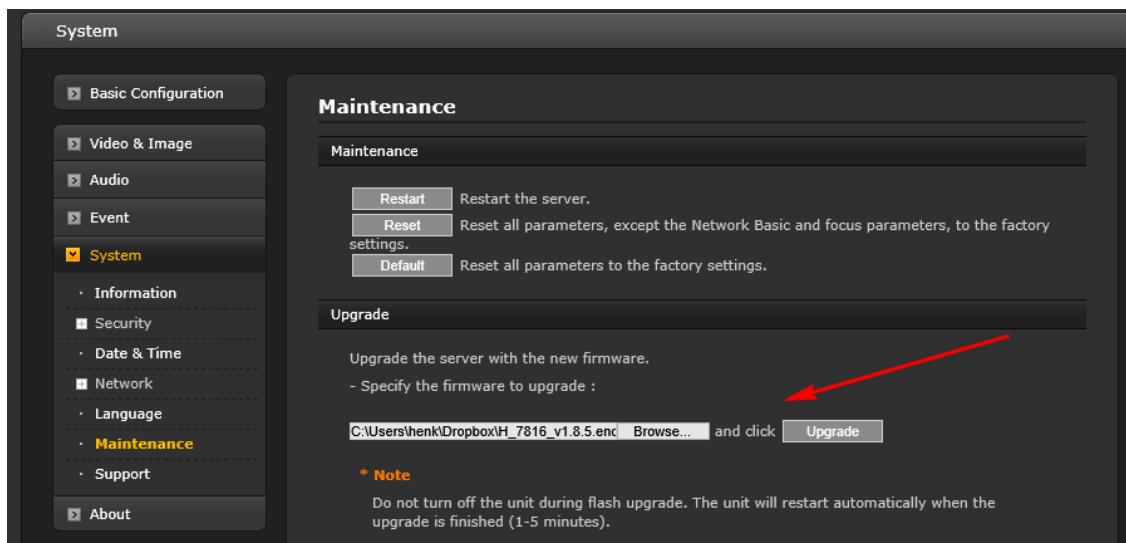
Download the firmware to your PC. Go to the camera's Maintenance screen:

Open the Upgrade section and use the Browse button to locate the firmware on your PC. Press the upgrade button. During the upgrade process, do not turn off power to the camera. Wait at least 5 minutes and access the camera again.

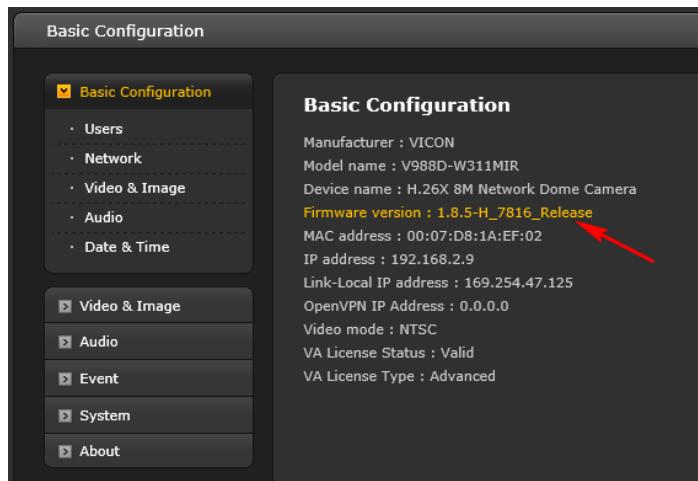
Once complete, the firmware version can be checked from the Basic Configuration screen.
