Release Notes

Updated Firmware (H_7816) for cameras: V988B-W311MIR, V988D-W311MIR, V988-W-NL V985D-W311MIR and V985B-W311MIR

General Description

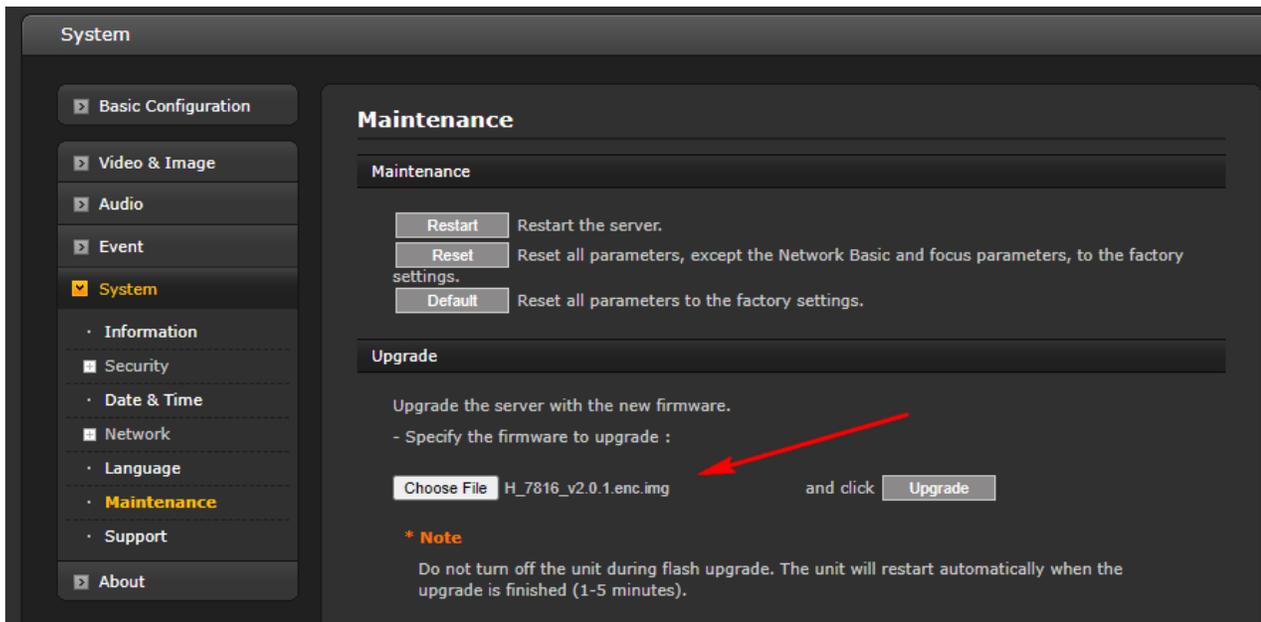
Download the firmware to your PC. Go to the camera's Maintenance screen:

Open the Upgrade section and use the Browse button to locate the firmware on your PC. Press the upgrade button. During the upgrade process, do not turn off power to the camera. Wait at least 5 minutes and access the camera again.

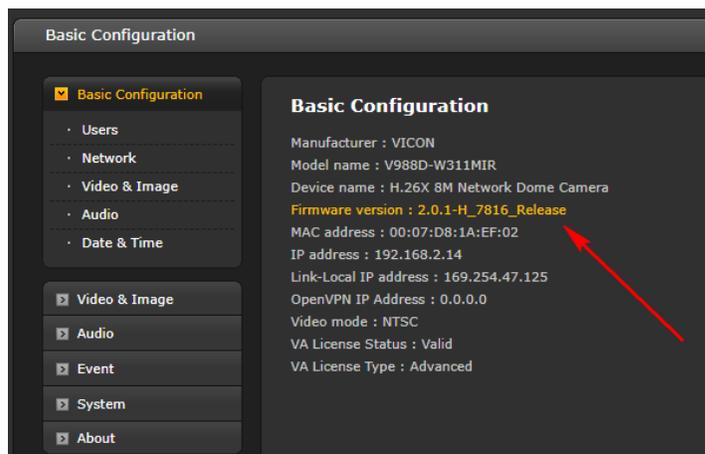
Once complete, the firmware version can be checked from the Basic Configuration screen.
