Release Notes

Updated Firmware (H_7817_Fisheye) for V8360W-12 and V8360W-6 Cameras

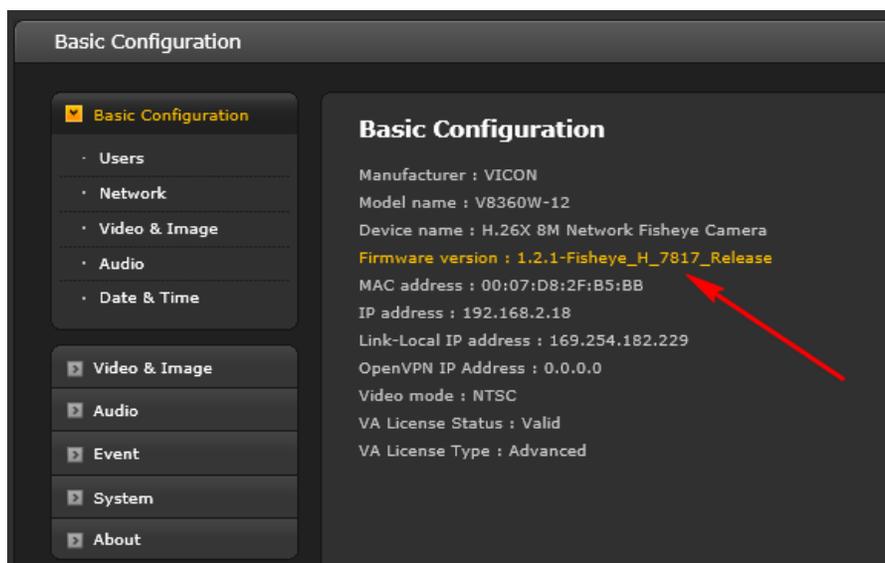
Once complete, the firmware version can be checked from the Basic Configuration screen :
