Release Notes

February 2021

Updated Firmware (H_6411) for V804D-WIR, V804D-W312MIR, V984D-W312MIR and V984B-W312MIR Cameras

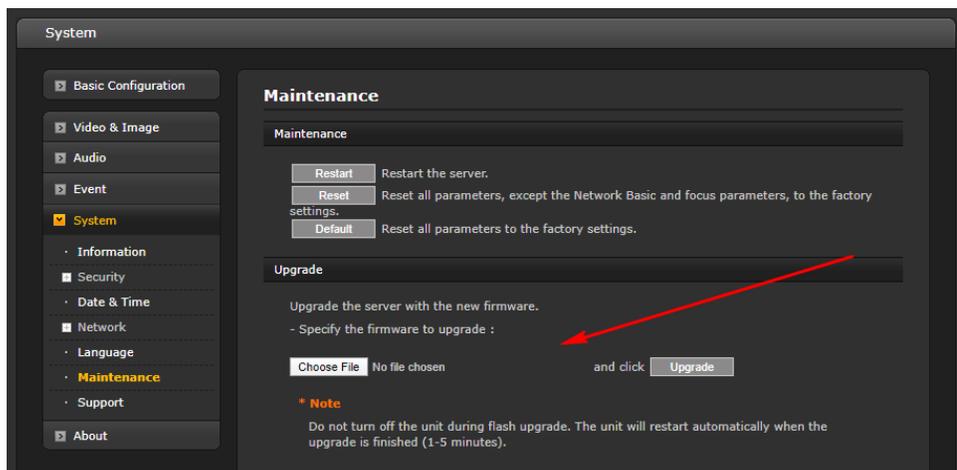
Go to the camera’s Maintenance screen. Open the Upgrade section and use the Browse button to locate the firmware on your PC. Press the Upgrade button. During the upgrade process, do not turn off power to the camera. Wait at least 5 minutes and access the camera again.

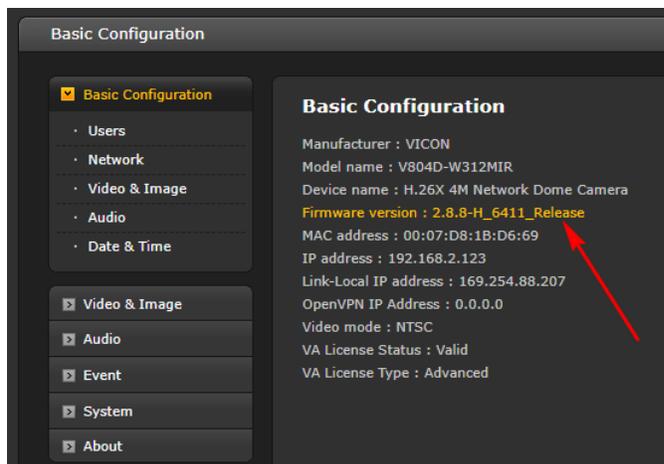
Once complete, the firmware version can be checked from the Basic Configuration screen.
