Release Notes

February 2021

Updated Firmware (H_7817_PTZ) for SN688D-WIR Cameras

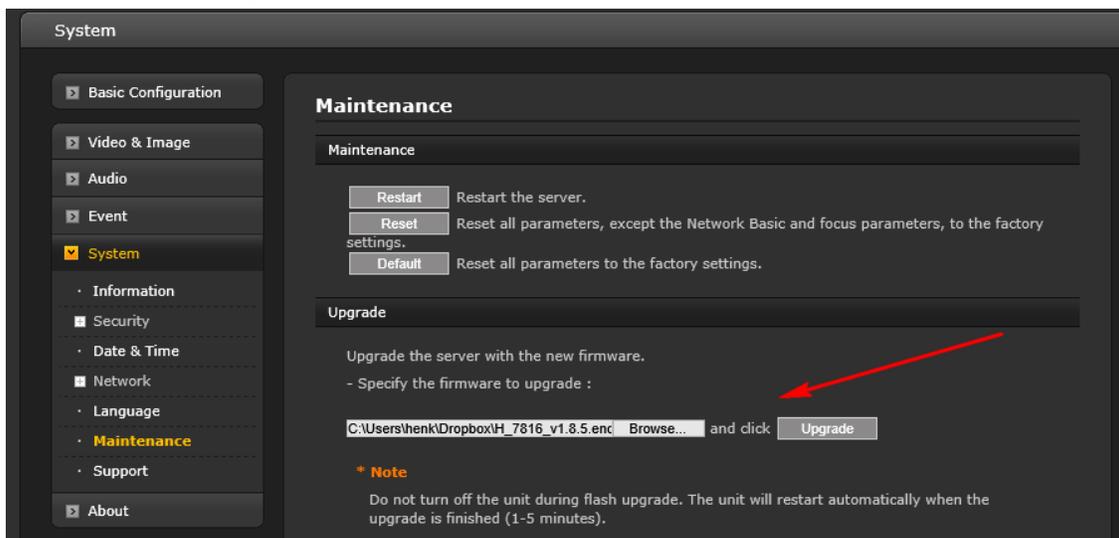
Download the firmware to your PC. Go to the camera's Maintenance screen:

Open the Upgrade section and use the Browse button to locate the firmware on your PC. Press the upgrade button. During the upgrade process, do not turn off power to the camera. Wait at least 5 minutes and access the camera again.

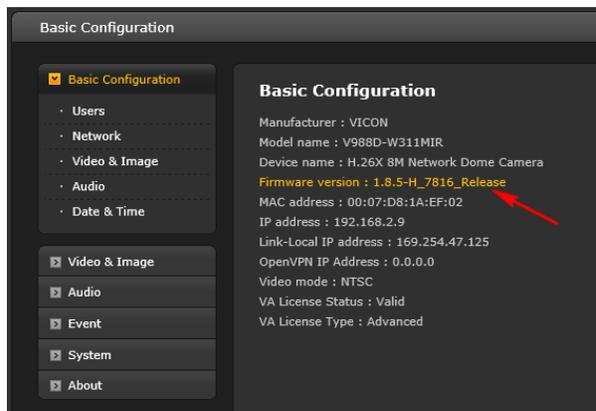
Once complete, the firmware version can be checked from the Basic Configuration screen.
