Updated Firmware (H-6314_PTZ) for SN683D-WIR Camera

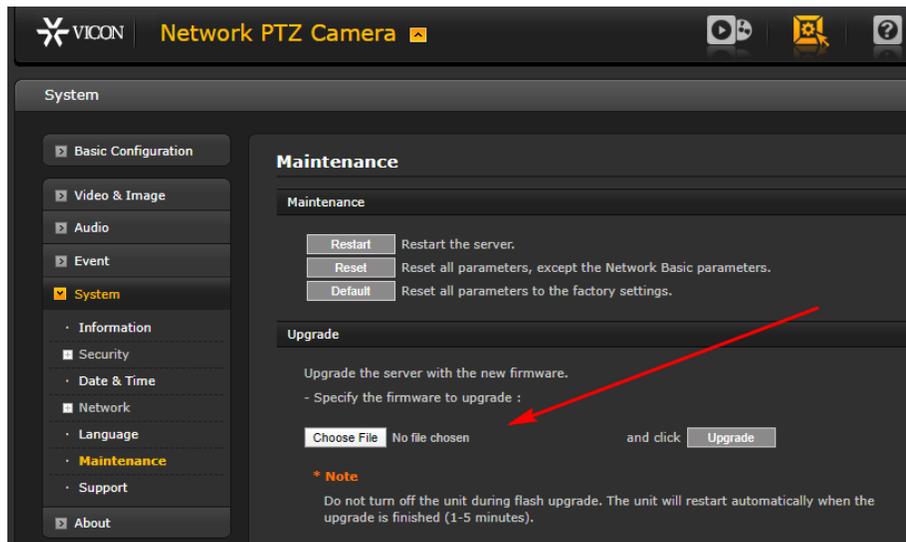
Download the firmware to your PC. Go to the camera's Maintenance screen:

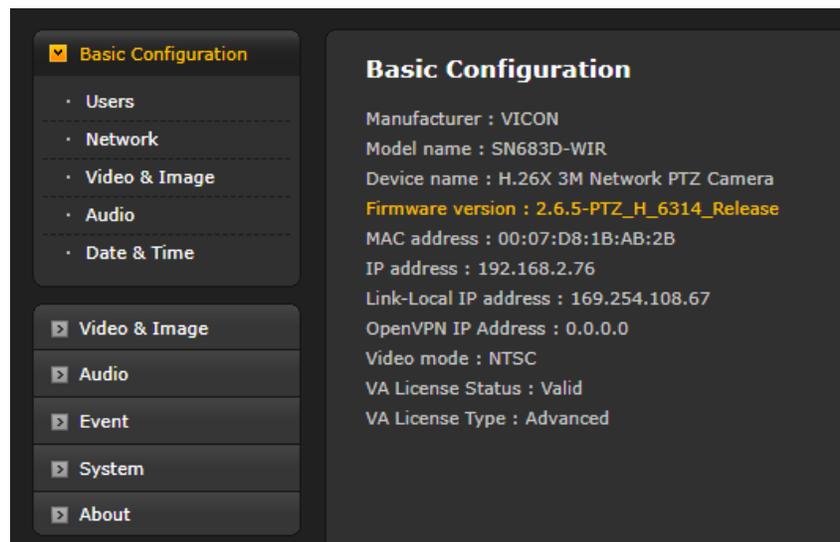
Open the Upgrade section and use the Browse button to locate the firmware on your PC. Press the upgrade button. During the upgrade process, do not turn off power to the camera. Wait at least 5 minutes and access the camera again. Once complete, the firmware version can be checked on the Basic Configuration screen.
