## Updated Firmware (H\_2411) for: V812B-IR, V814B-IR, V812B-312MIR, V814B-312MIR, V932D-IR-1, V934D-IR, V9521D-312MIR, V9541D-312MIR Cameras

### General Description

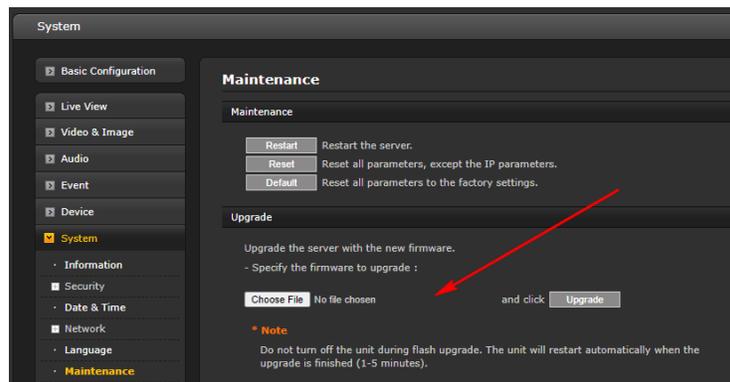
Download the firmware to your PC. Go to the camera's Maintenance screen:

Open the Upgrade section and use the Browse button to locate the firmware on your PC. Press the upgrade button. During the upgrade process, do not turn off power to the camera. Wait at least 5 minutes and access the camera again.

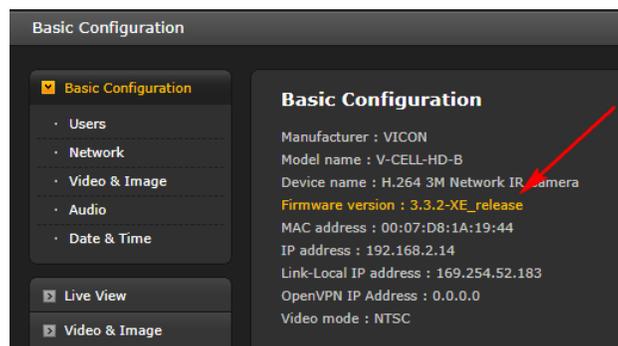
Once complete, the firmware version can be checked from the Basic Configuration screen:
