Updated Firmware (H_5213_PTZ) for the SN693V Camera

General Description

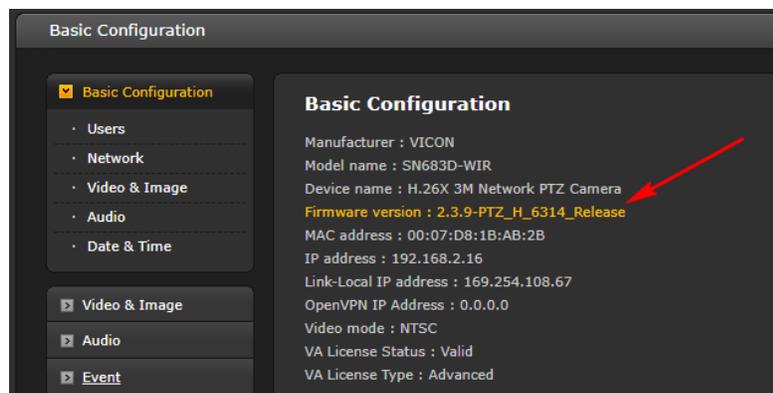
Once complete, the firmware version can be checked from the Basic Configuration screen.
