# Release Notes

March 2021

## Updated Firmware (H\_5213) for V802D-WIR, V802D-W312MIR, V982D-W312MIR and V982B-W312MIR Cameras

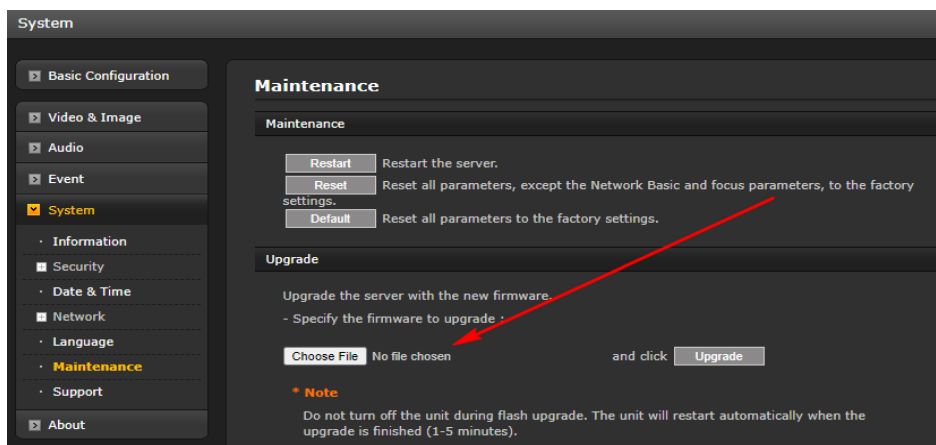
Go to the camera’s Maintenance screen. Open the Upgrade section and use the Browse button to locate the firmware on your PC. Press the Upgrade button. During the upgrade process, do not turn off power to the camera. Wait at least 5 minutes and access the camera again.

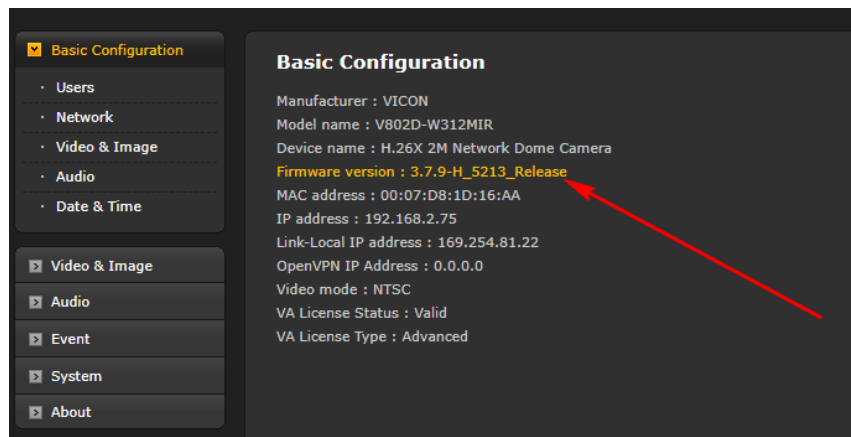
Once complete, the firmware version can be checked from the Basic Configuration screen.
