Release Notes

July 2021

Firmware Update for V1020-WIR-360 Multi-Sensor Camera

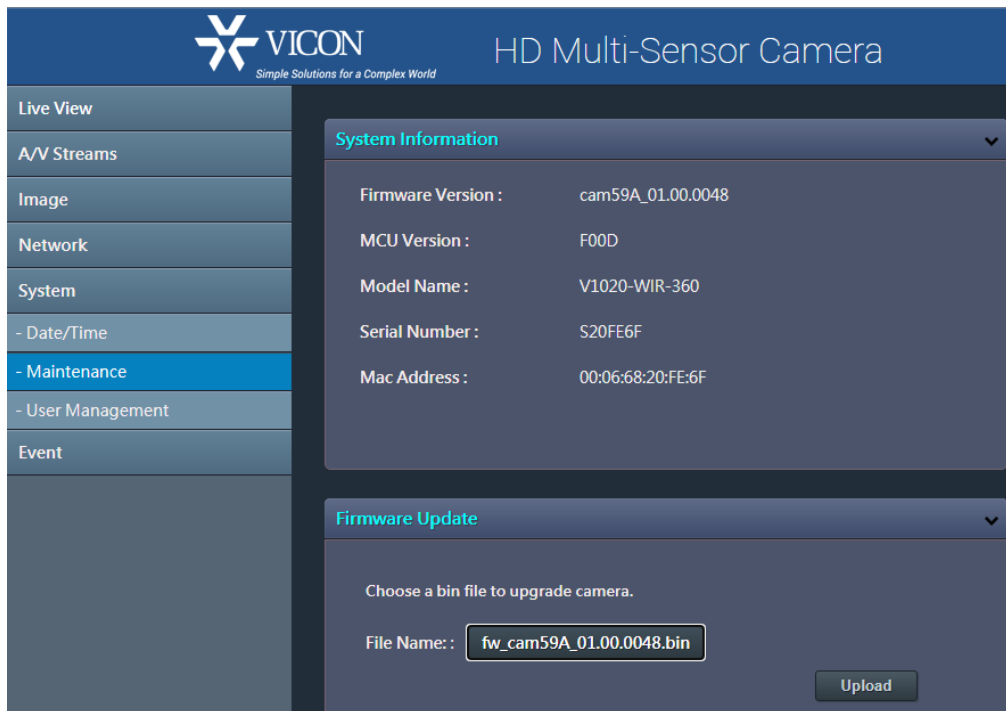
Download the firmware to your PC. Go to the camera's Maintenance screen. Click "Choose a file" to point to the new firmware file and select "Upload":

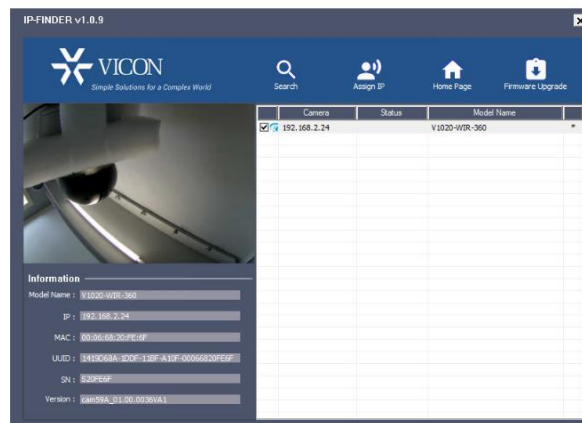
Alternatively, the Vicon IP Finder utility allows updating multiple cameras at the same time:
