# Release Notes

October 2021

## Firmware Update for Camera Models V2002B-W313MIR, V2002D-W313MIR, V2002D-W28IR

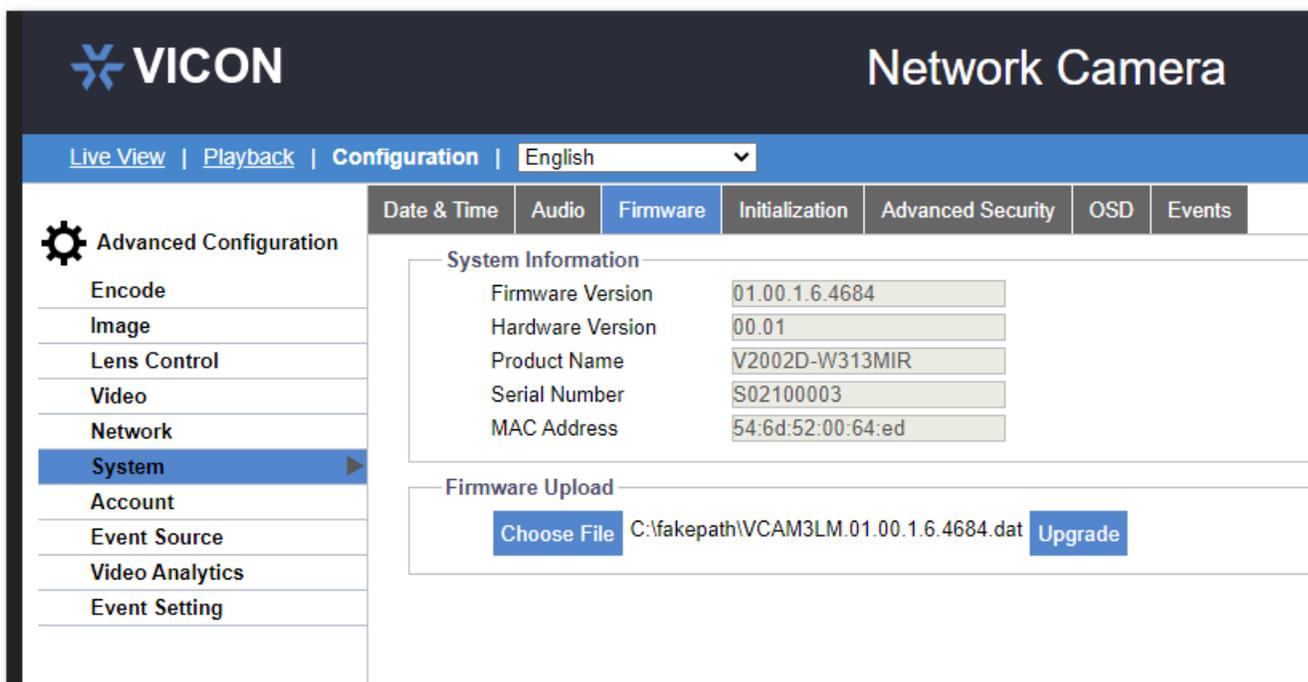
In the camera web interface, under Configuration > System > Firmware, press "Choose File" and select the downloaded firmware file. Then press "Upgrade" to start the update. The camera will install the update and reboot with the new firmware version:

The screenshot shows the Vicon Network Camera web interface. The top navigation bar includes 'Live View', 'Playback', 'Configuration', and a language dropdown set to 'English'. The left sidebar shows 'Advanced Configuration' with a gear icon and a list of menu items: Encode, Image, Lens Control, Video, Network, System (highlighted), Account, Event Source, Video Analytics, and Event Setting. The main content area has tabs for 'Date & Time', 'Audio', 'Firmware', 'Initialization', 'Advanced Security', 'OSD', and 'Events'. Under the 'Firmware' tab, there are two sections: 'System Information' and 'Firmware Upload'. The 'System Information' section displays the following details:

System Information	
Firmware Version	01.00.1.6.4684
Hardware Version	00.01
Product Name	V2002D-W313MIR
Serial Number	S02100003
MAC Address	54:6d:52:00:64:ed

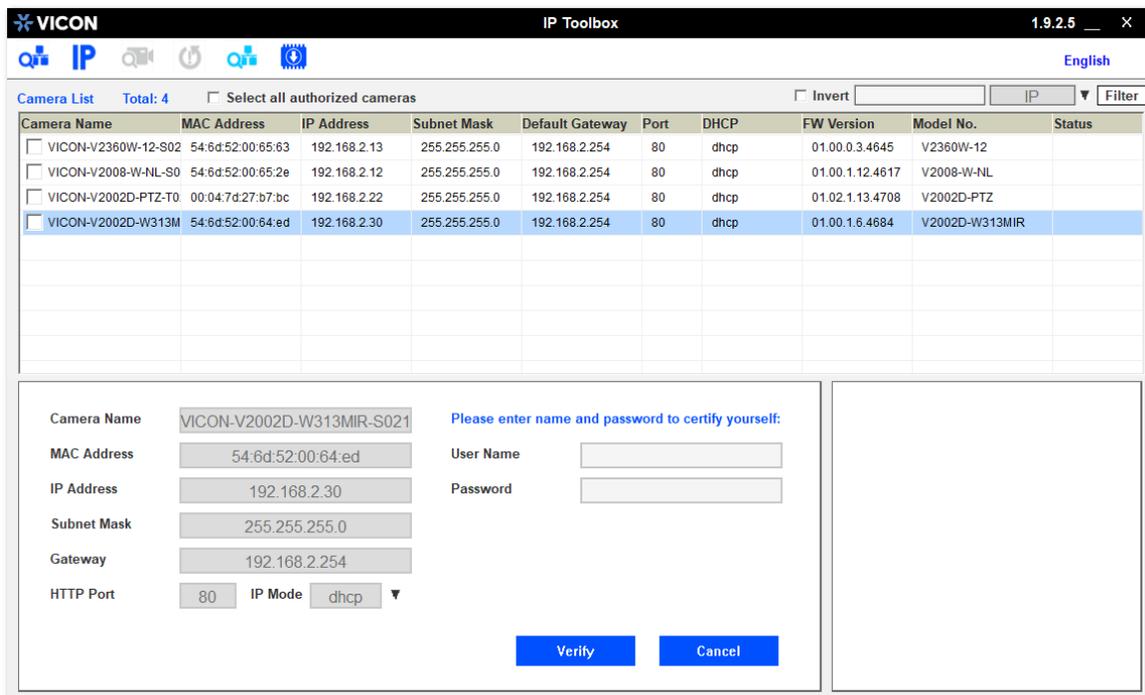
Download and install the IP Toolbox utility from the Vicon webpage:

Scan the network to discover the applicable cameras on the local network. Press the firmware update button, select the downloaded firmware and fill in the camera credentials. Press the "+" button, and the list of cameras will appear that are suitable for the selected firmware. (Note that the cameras must have the same credentials, if more than one camera is updated.)

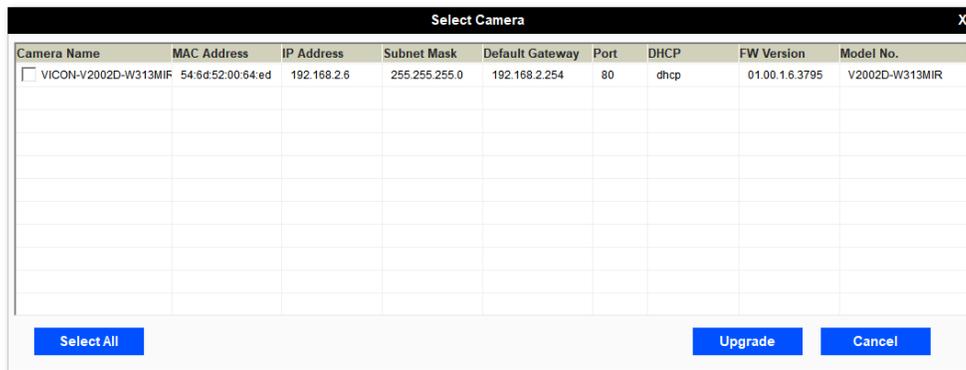
Select the cameras to be updated or just press "Select All" to update all cameras. Now press "Update." The camera will install the update and reboot with the new firmware version.
