# Release Notes

October 2021

## Firmware Update for Camera Models V2008-W-NL, V2008B-W310MIR, V2008D-W310MIR

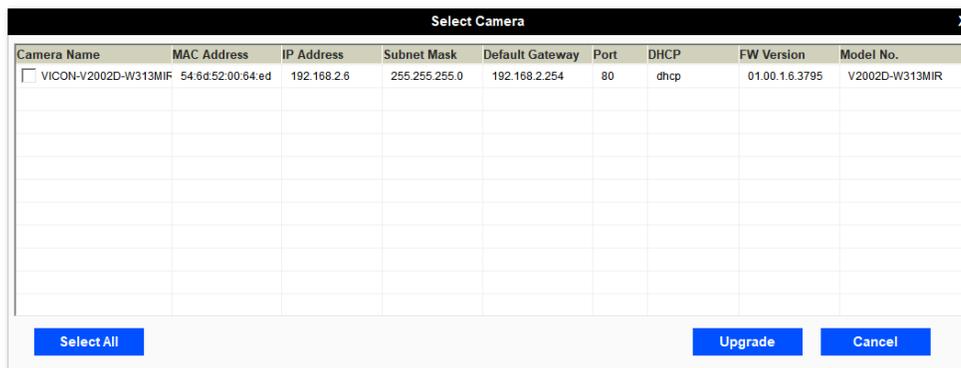
Select the cameras to be updated or just press "Select All" to update all cameras. Now press "Update." The camera will install the update and reboot with the new firmware version.
