Release Notes

Firmware Update for Camera Model: V2002D-PTZ

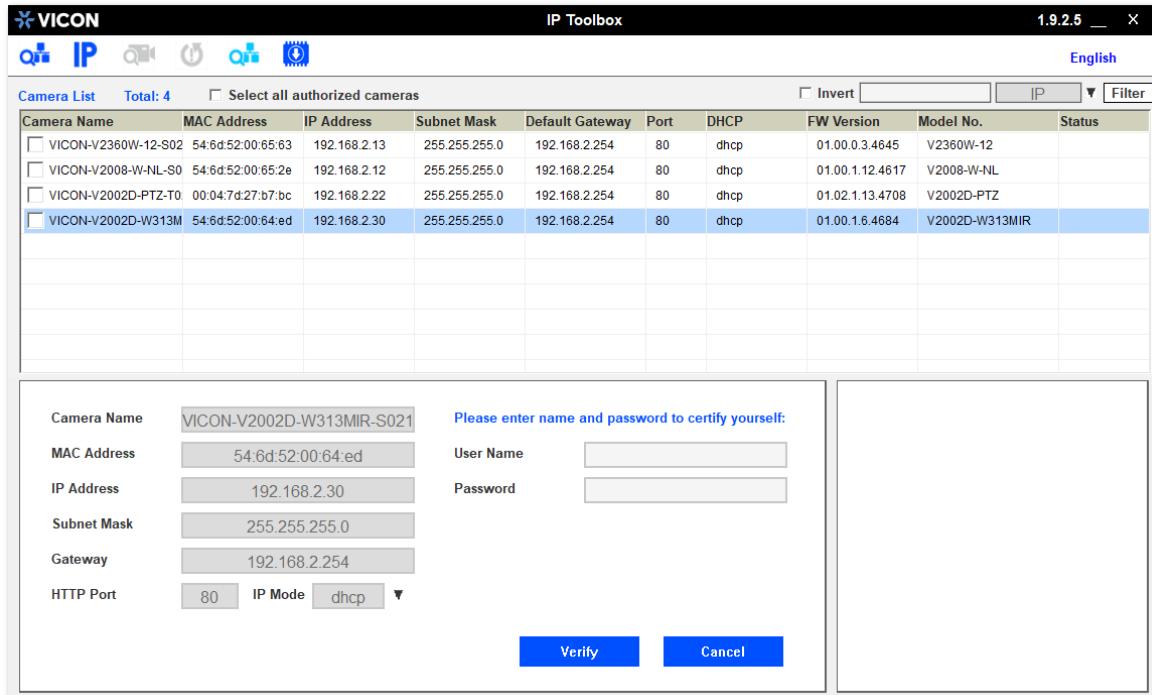
Scan the network to discover the applicable cameras on the local network. Press the firmware update button, select the downloaded firmware and fill in the camera credentials.

Download and install the IP Toolbox utility from the Vicon webpage:

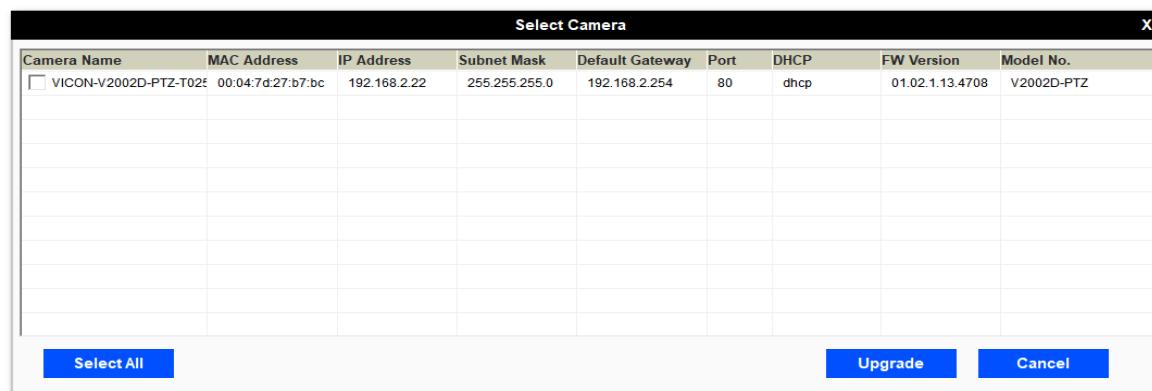
Press the "+" button, and the list of cameras will appear that are suitable for the selected firmware. (Note that the cameras must have the same credentials, if more than one camera is updated.)

Select the cameras to be updated or just press "Select All" to update all cameras.

Now press "Update." The camera will install the update and reboot with the new firmware version.
