Release Notes

February 2022

Firmware Update for Camera Models V2102B-W313MIR, V2105B-W313MIR, V2105B-W28IR, V2102B-W28IR, V2102D-W313MIR, V2105D-W313MIR

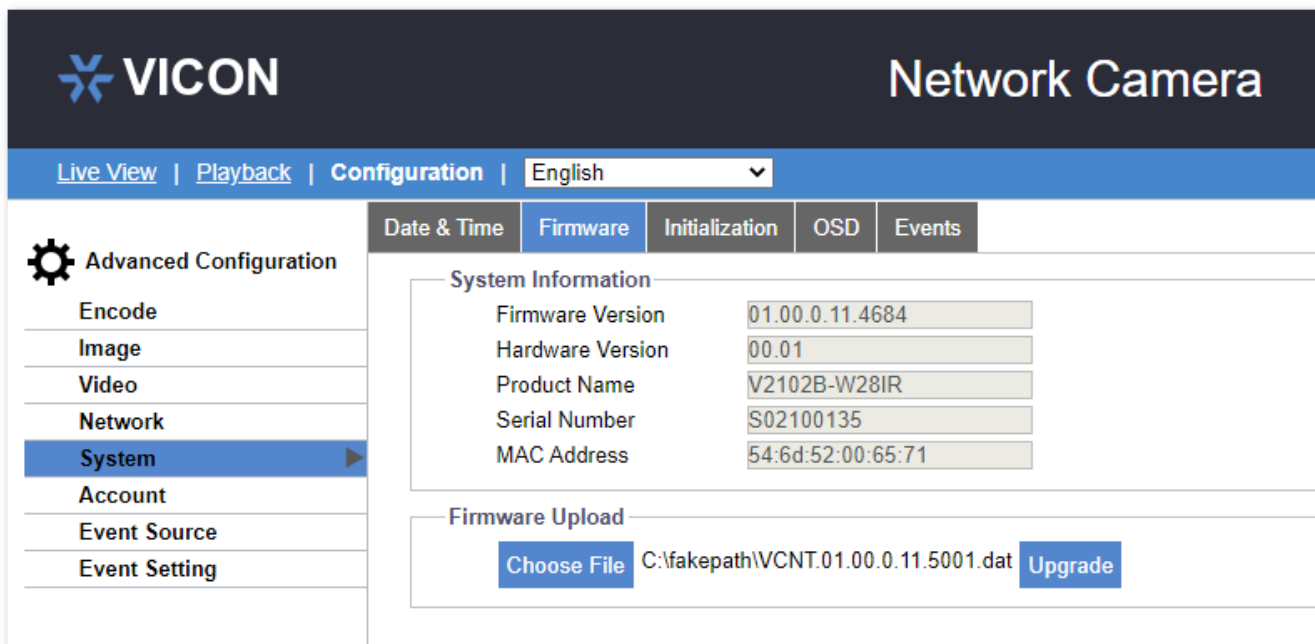
In the camera web interface, under Configuration > System > Firmware, press "Choose File" and select the downloaded firmware file. Then press "Upgrade" to start the update. The camera will install the update and reboot with the new firmware version:

The screenshot shows the Vicon Network Camera web interface. The top navigation bar includes "Live View", "Playback", "Configuration", and a language dropdown set to "English". The left sidebar shows "Advanced Configuration" with sub-items: Encode, Image, Video, Network, System (highlighted), Account, Event Source, and Event Setting. The main content area has tabs for "Date & Time", "Firmware", "Initialization", "OSD", and "Events". Under the "Firmware" tab, there are two sections: "System Information" and "Firmware Upload".

System Information	
Firmware Version	01.00.0.11.4684
Hardware Version	00.01
Product Name	V2102B-W28IR
Serial Number	S02100135
MAC Address	54:6d:52:00:65:71

The "Firmware Upload" section contains a "Choose File" button, a text input field with the path "C:\fakepath\VCNT.01.00.0.11.5001.dat", and an "Upgrade" button.
