# Release Notes

November 2022

## Firmware Update for Camera Models V2102D-W313MIR, V2102B-W313MIR, V2102B-W28IR, V2105D-W313MIR, V2105B-W313MIR and V2105B-W28IR

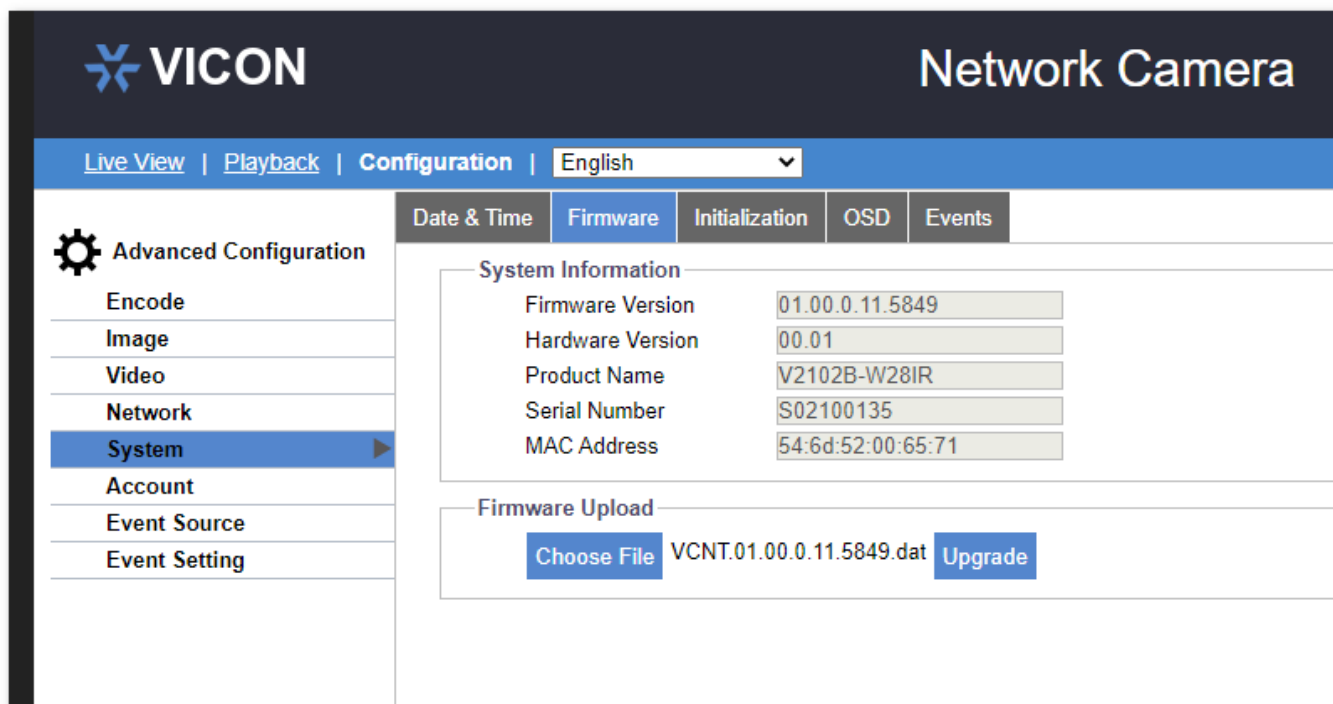
In the camera web interface, under Configuration > System > Firmware, press "Choose File" under "Firmware Upload" and select the downloaded firmware file. Then press "Upgrade" to start the update. The camera will install the update and reboot with the new firmware version:

The screenshot shows the Vicon Network Camera web interface. The top navigation bar includes 'Live View', 'Playback', 'Configuration', and a language dropdown set to 'English'. The left sidebar shows 'Advanced Configuration' with options for Encode, Image, Video, Network, System (selected), Account, Event Source, and Event Setting. The main content area has tabs for 'Date & Time', 'Firmware', 'Initialization', 'OSD', and 'Events'. Under the 'Firmware' tab, there is a 'System Information' section with the following details:

Firmware Version	01.00.0.11.5849
Hardware Version	00.01
Product Name	V2102B-W28IR
Serial Number	S02100135
MAC Address	54:6d:52:00:65:71
