IQEye Cameras Firmware

General Description

Rev1.3

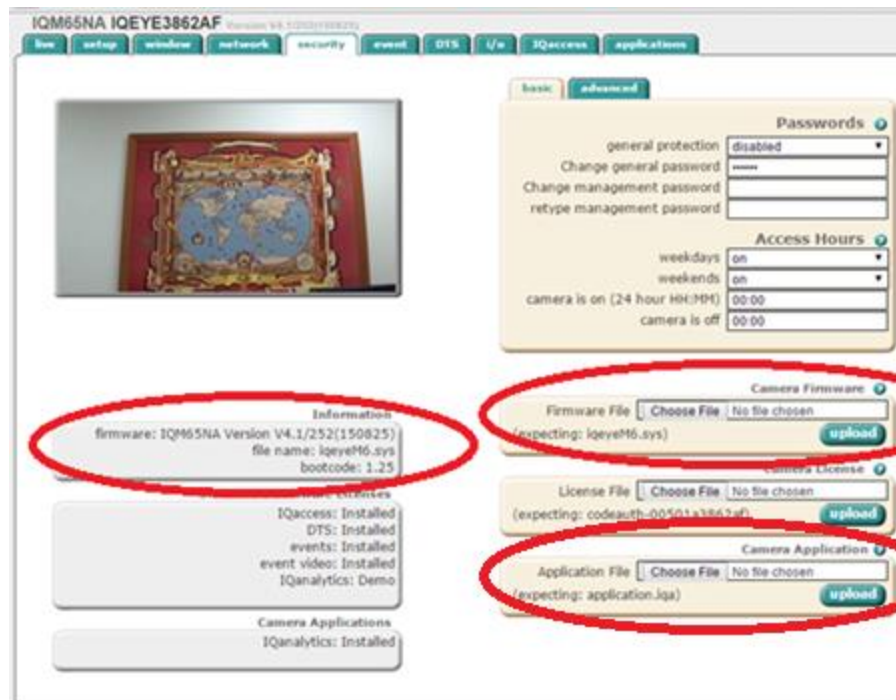
<http://www.vicon-security.com/learn-and-support/software-downloads#iqeye-camera-software> Download the firmware to your PC. Go to the camera's security tab.

Go to the camera firmware section and use the "Choose File" button to locate the firmware on your PC. Press the upload button. During the upgrade process, do not turn off the power to the camera. The new firmware should be installed. This can be verified on the information window on the left side.

Note! Updating to this specific firmware should be done twice (update once and then update again) to allow the protected firmware area to be created and then have it updated with the latest version!

The latest Vicon Analytics application is also available in the same location and should be updated as an application file after the new firmware has been successfully updated (only once)
