IQeye Cameras Firmware

General Description

With the release of the IQB9 series of cameras, Vicon engineering has released firmware version 4.2/107. These release notes outline known issues and limitations with this firmware. The accompanying IQfinder and IQmanager discovery and setup tools do not change.

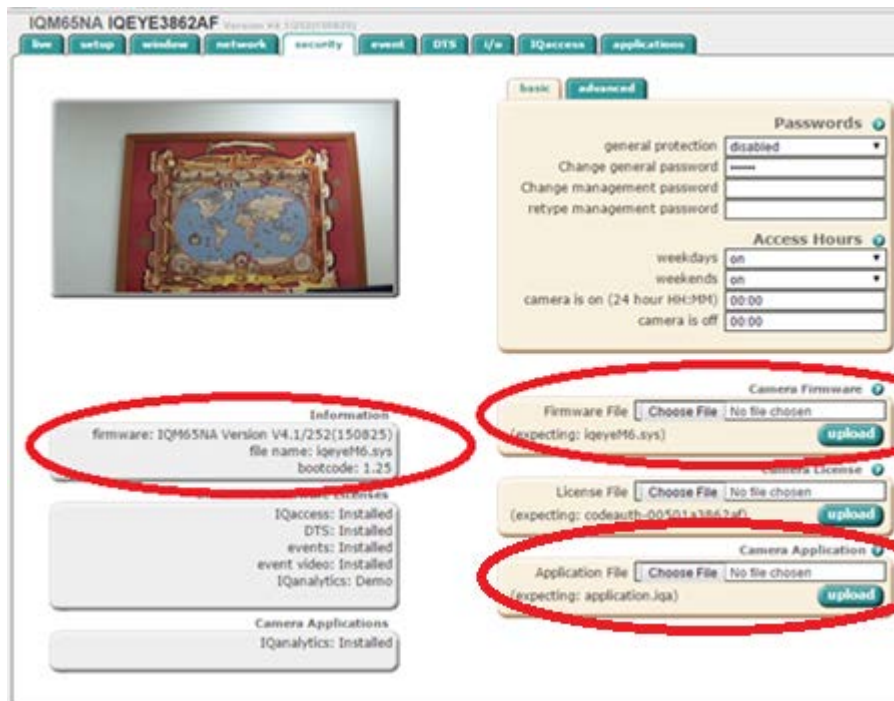
<http://www.vicon-security.com/learn-and-support/software-downloads#iqeye-camera-software> Download the firmware to your PC. Go to the camera's security tab.

Go to the camera firmware section and use the "Choose File" button to locate the firmware on your PC. Press the upload button. During the upgrade process, do not turn off the power to the camera. The new firmware should be installed. This can be verified on the information window on the left side.
