V9xx Series Cameras Firmware

General Description

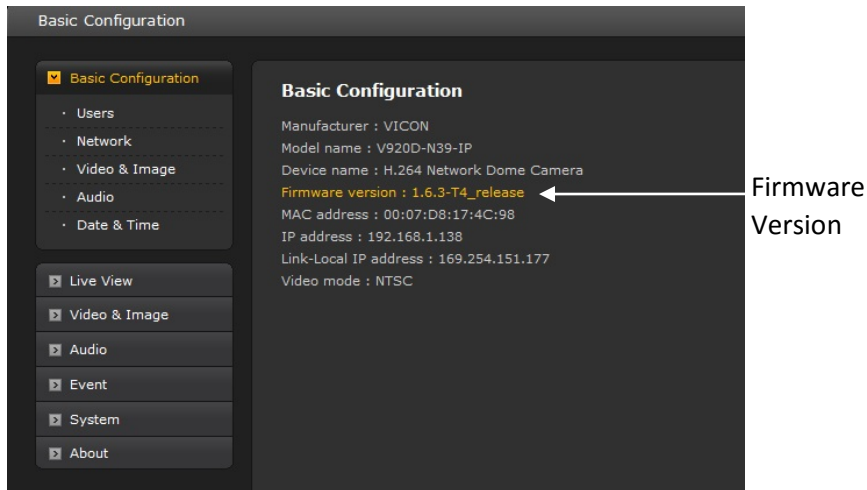
Go to the Upgrade section and use the Browse button to locate the firmware on your PC. Press the Upgrade button. During the upgrade process, do not turn off the power to the camera. Wait at least 5 minutes and access the camera again. The new firmware should be installed. This can be checked from the Basic Configuration screen.
